# Lake Chaffee Assessment on Aquatic Plant overgrowth in 2026

Prepared by Ben Scoular

# **COMPREHENSIVE ECOLOGICAL STATUS & MITIGATION REPORT**

**Location:** Lake Chaffee, Ashford, Windham County, CT

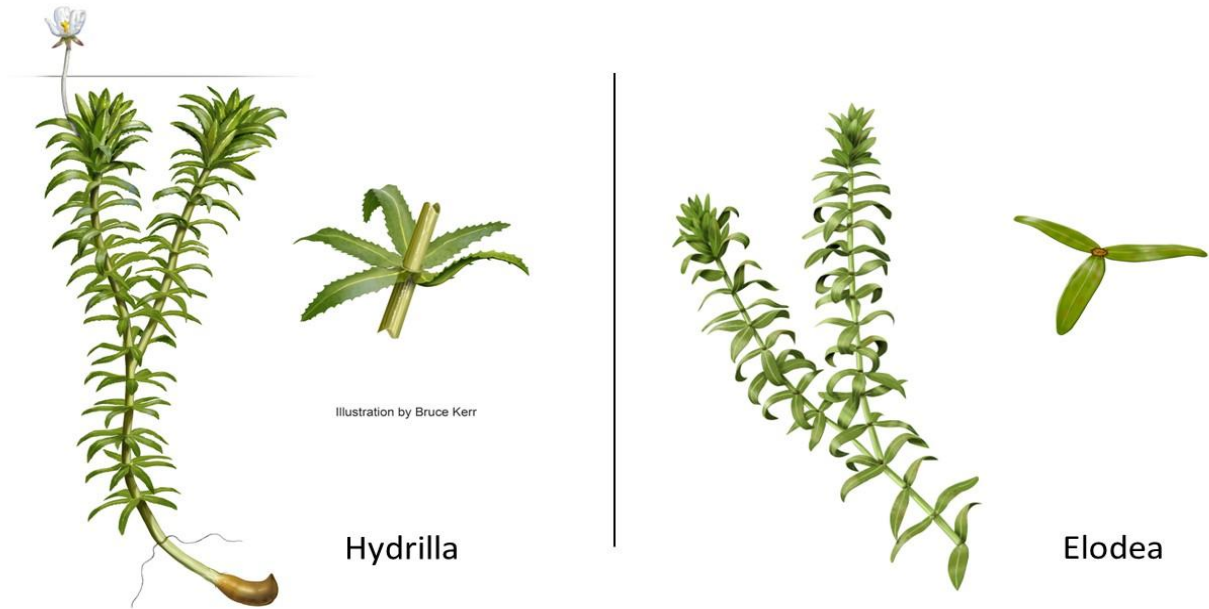
It is incredibly easy to confuse Elodea and Hydrilla at first glance. Both are submerged, freshwater aquatic plants with bright green, strap-like leaves that wrap around a central stem in clusters called **whorls**. However, telling them apart is highly important because native Elodea is a beneficial part of the ecosystem, whereas Hydrilla is an aggressive, highly destructive invasive species. The diagram below highlights exactly how their leaf structures and root systems differ.
